PERMIT APPLICATION FOR INLAND WETLANDS & WATERCOURSES  
ACTIVITY: (check one of the following)

RE: Inland Wetlands and Watercourses Activity Application  
Proposed Braeburn Road Drainage Culvert Rehabilitation

**CULVERT REPAIRS OF BRIDGE NO. 06076  
BRAEBURN ROAD OVER WEST BRANCH TROUT BROOK  
WEST HARTFORD, CONNECTICUT**

**PUBLICATION DATE: APRIL 14, 2016**

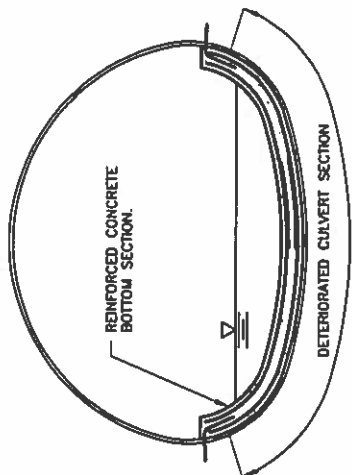
**SECTION A - OPTION 1**  
**REINFORCED CONCRETE**  
**BOTTOM SECTION**

- 1) Adding reinforced concrete to the culvert invert.
- 2) Repairing deteriorating sections with new corrugated steel bottom sections.
- 3) Using a culvert liner.

The proposed repairs to the culvert is the most common method based on the identified deterioration of the invert, specifically the section loss due to abrasion and corrosion. The modification provides the structural strength and long term protection. This has a minor effect of raising the water surface profiles upstream for a very short distance in the range of 25 to 50 feet (refer to the table on page 13, as shown on page C2 of the revised Schematic Design Report). The smoother concrete offsets some of the increase but not all, with the effect less at higher flow rates.

Option 1 was chosen since it is more reliable, easy to construct and maintain, and will provide long term cost savings for the Town.

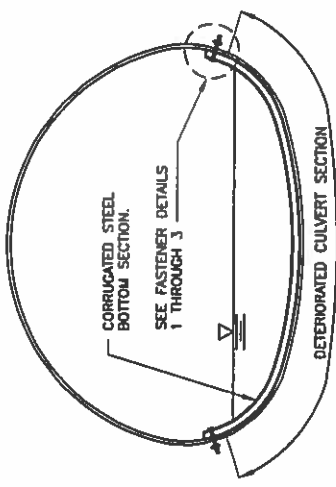
**SECTION A - OPTION 2**  
**CORRUGATED STEEL SECTION**  
**WITH FASTENERS**

An alternative to the proposed repair included fabricating new custom plates for the bottom and up part of the sides. This would have negligible effect on the water surface profile. Proprietary systems to line the culvert was another alternative. Based on the size of the culvert, the lining would also be custom made or spray applied. We are not confident that the lining would last as long as the manufactures advertise, nor supply the strength requirements and be thin enough to have minimal effect on the water surface profile.
